**AN ASSESSMENT OF
ABANDONED MINES IN
NORTHERN SASKATCHEWAN
(YEAR 3)**

MAY, 2003

**PREPARED FOR:
SASKATCHEWAN ENVIRONMENT**

Prepared by: Clifton Associates Ltd.
on behalf of
P.A.N.S. Joint Venture

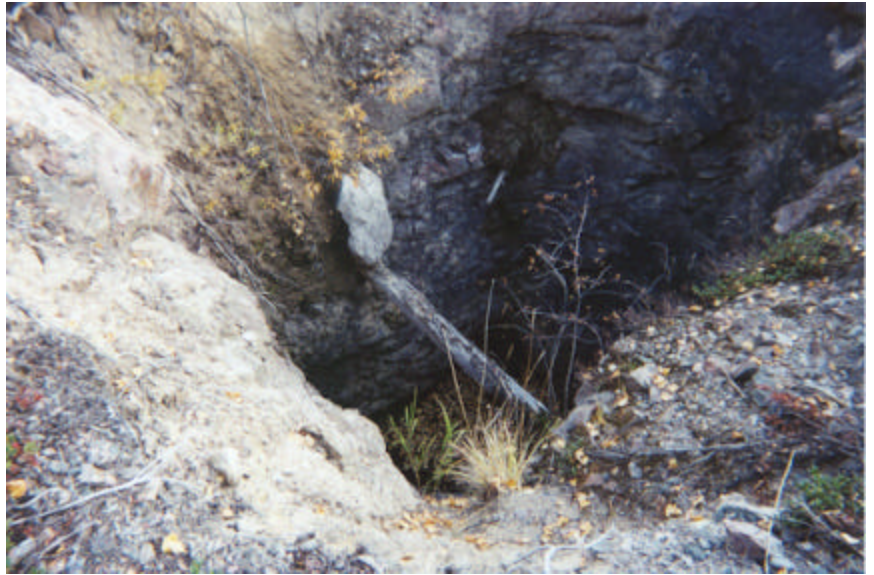
Photograph 6.1-2. Neely Lake-Trench
and Waste Rock-September 30, 2002.

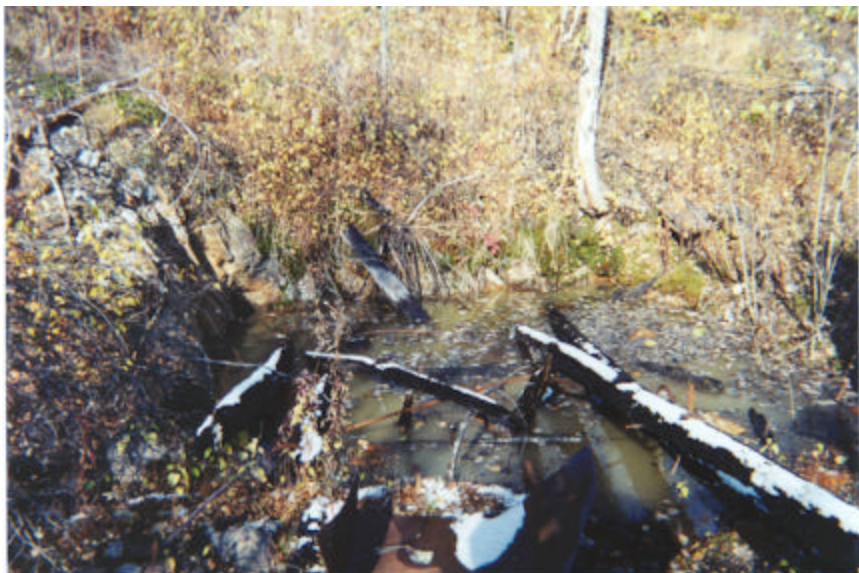
Photograph 6.5-1. Don Henry Site-Flooded Shaft-October 01, 2002.

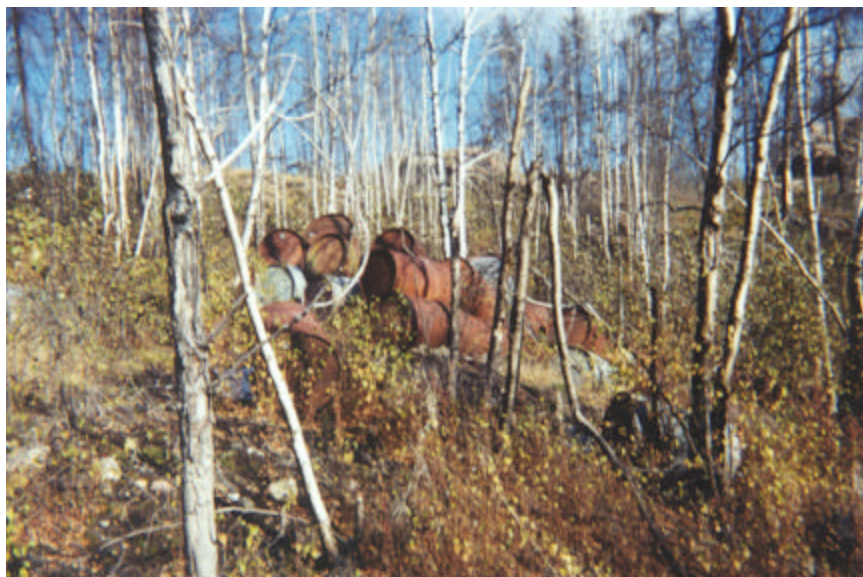
Photograph 6.5-2. Don Henry Site-Debris-October 01, 2002.

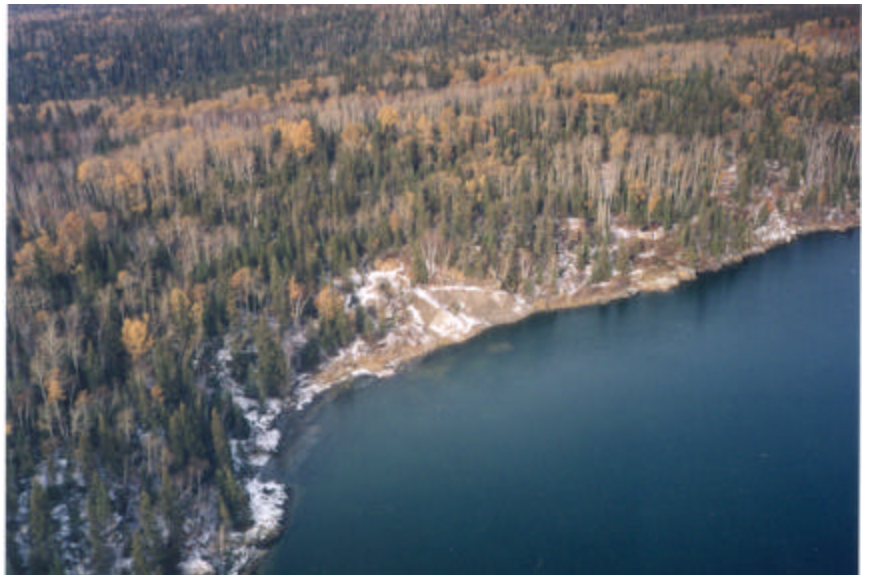
Photograph 6.7-1. Prince Albert Mine-Aerial View-October 23, 2002

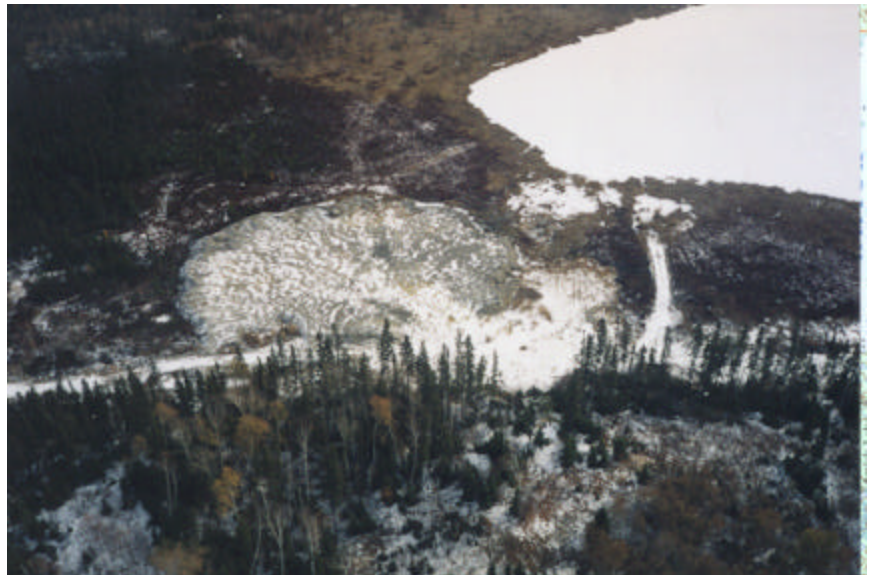
Photograph 6.8-2. Laurel Lake Gold Mine-Portal-October 18, 2002

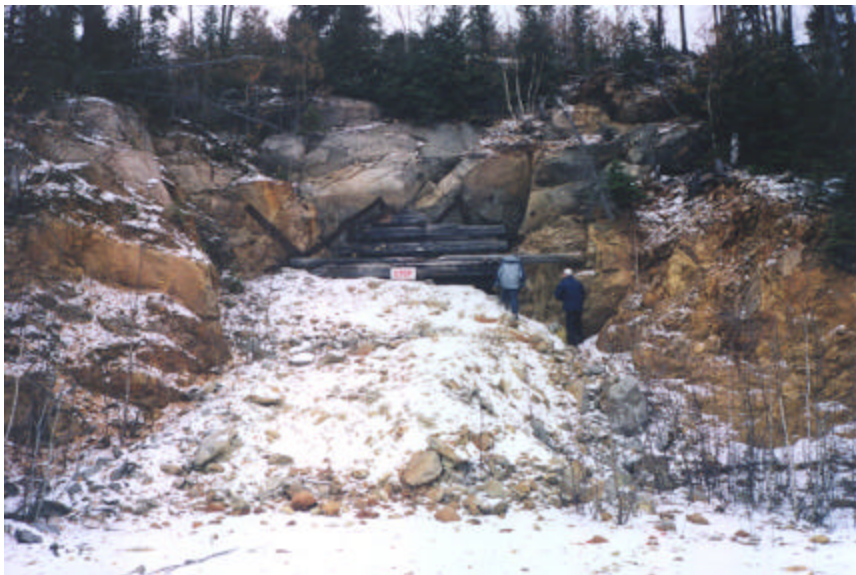
Photograph 6.8-3. Laurel Lake Gold Mine-Panoramic View of Waste Rock-October 18, 2002

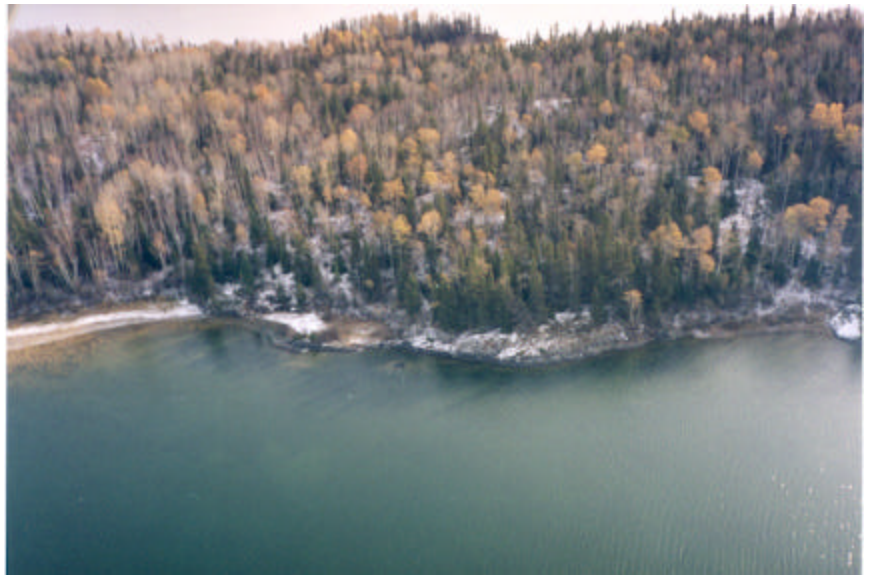
Photograph 6.9-2. Amisk Gold Mine-Trench 'A'-October 19, 2002.

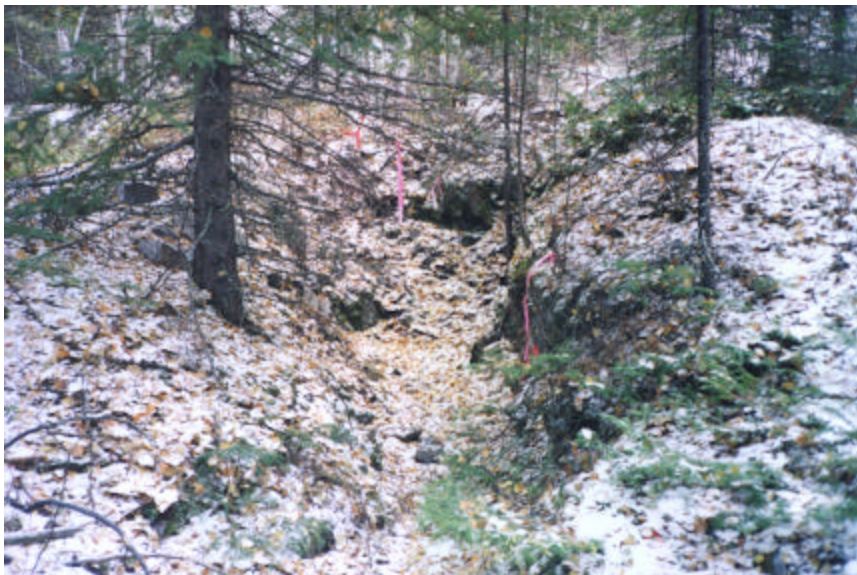
Photograph 6.9-3. Amisk Gold Mine-Prospect Shaft/Pit-October 19, 2002

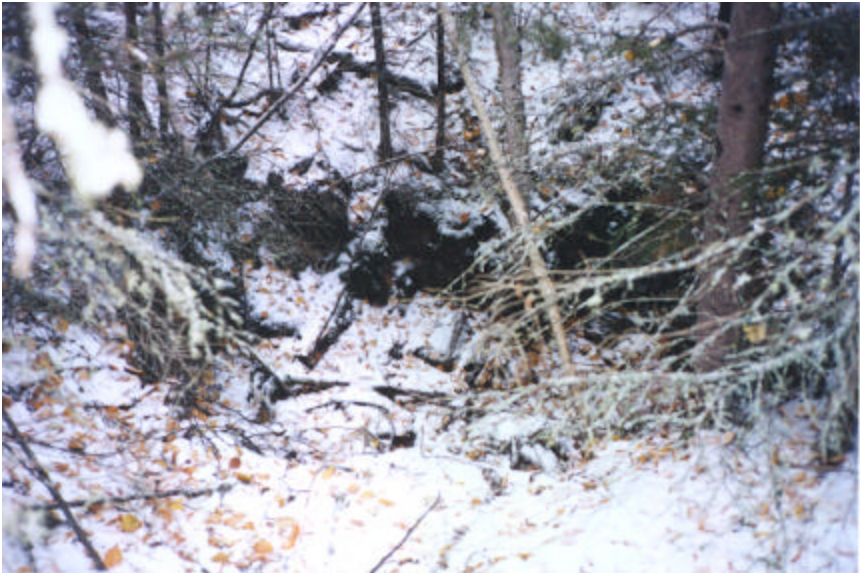
Photograph 6.11-2. Waverly Island Site-Trench 'B'-October 20, 2002.

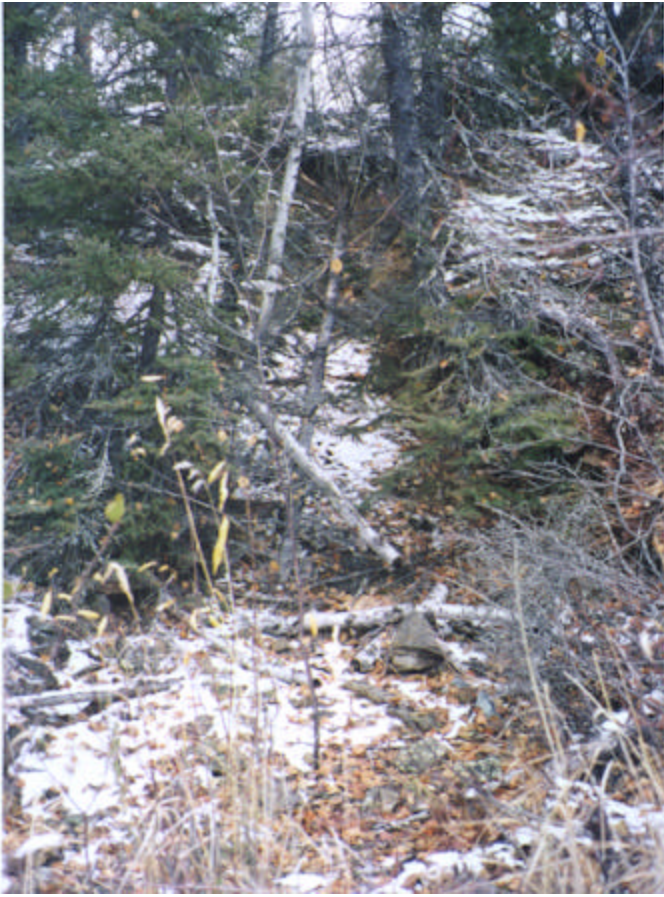
Photograph 6.12-1. Sonora Deposit-Trench 'C'-October 20, 2002.

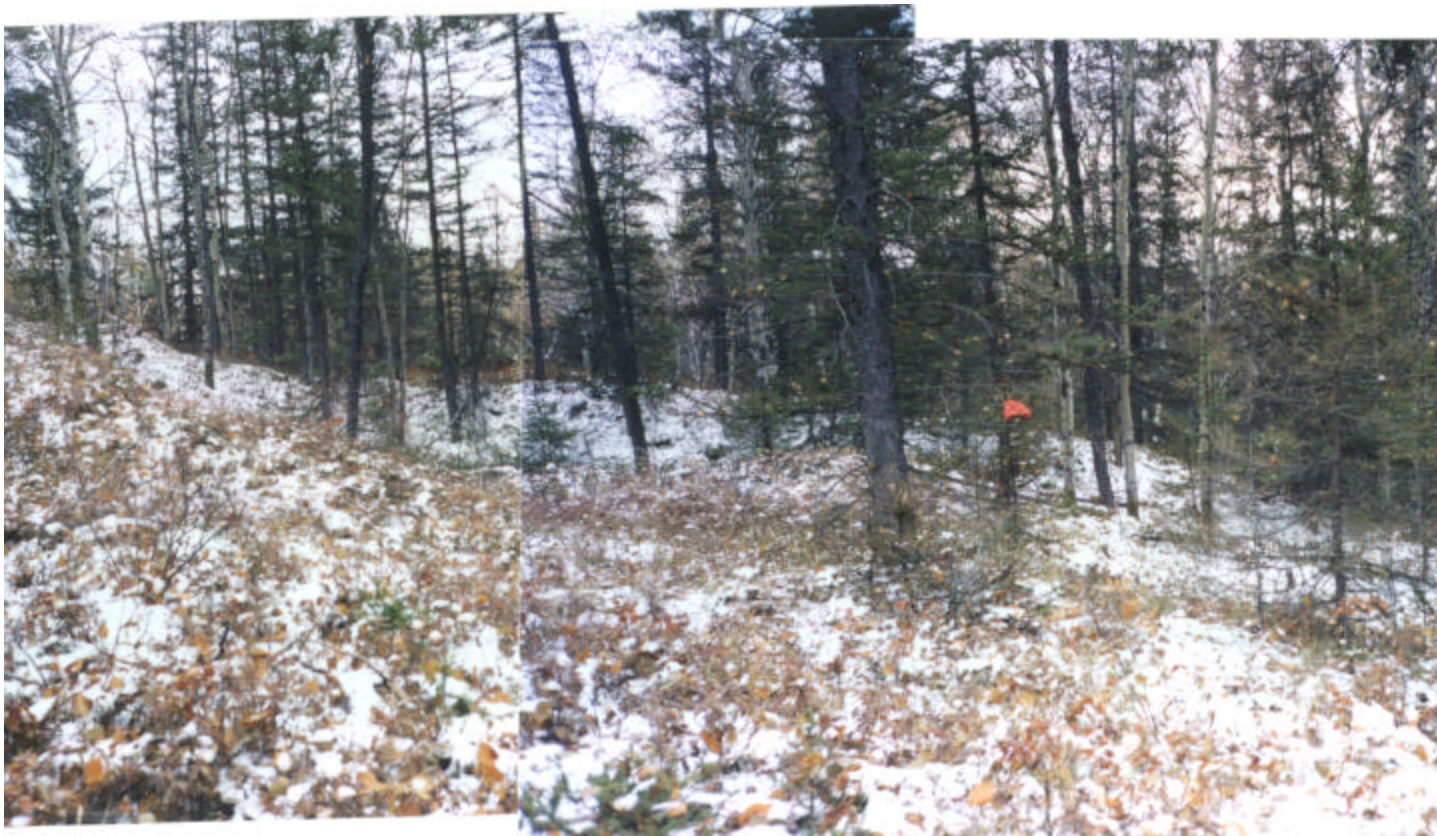
Photograph 6.14-1. Star Occurrence-General View (Small Pit is Near Orange Marker)-October 21, 2002

No follow-up work is required for this site. Given the remoteness and difficulty in accessing the site, it is likely there will be minimal people visiting the site. Furthermore, there was only one shallow small pit that poses no safety hazard.

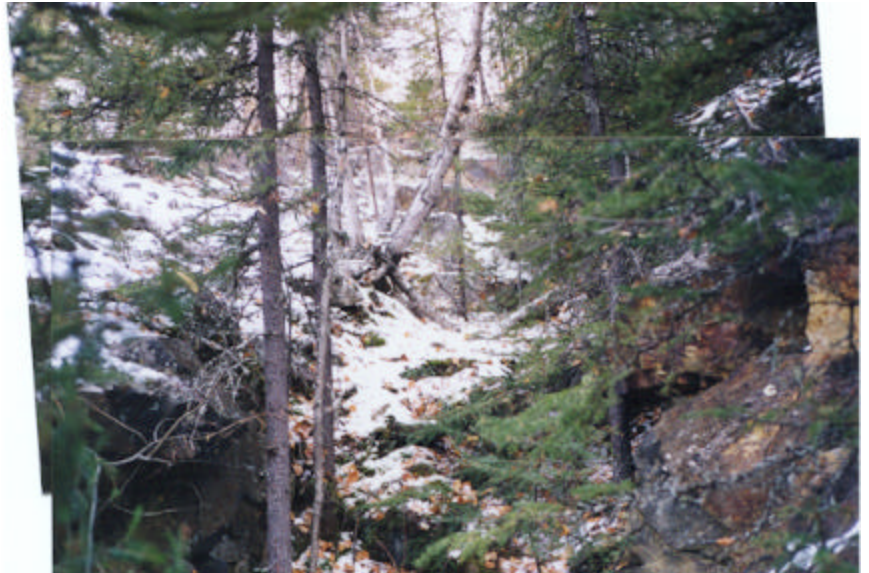
Photograph 6.16-2. Hannay Deposit View of Site Along Shoreline-October 22, 2002

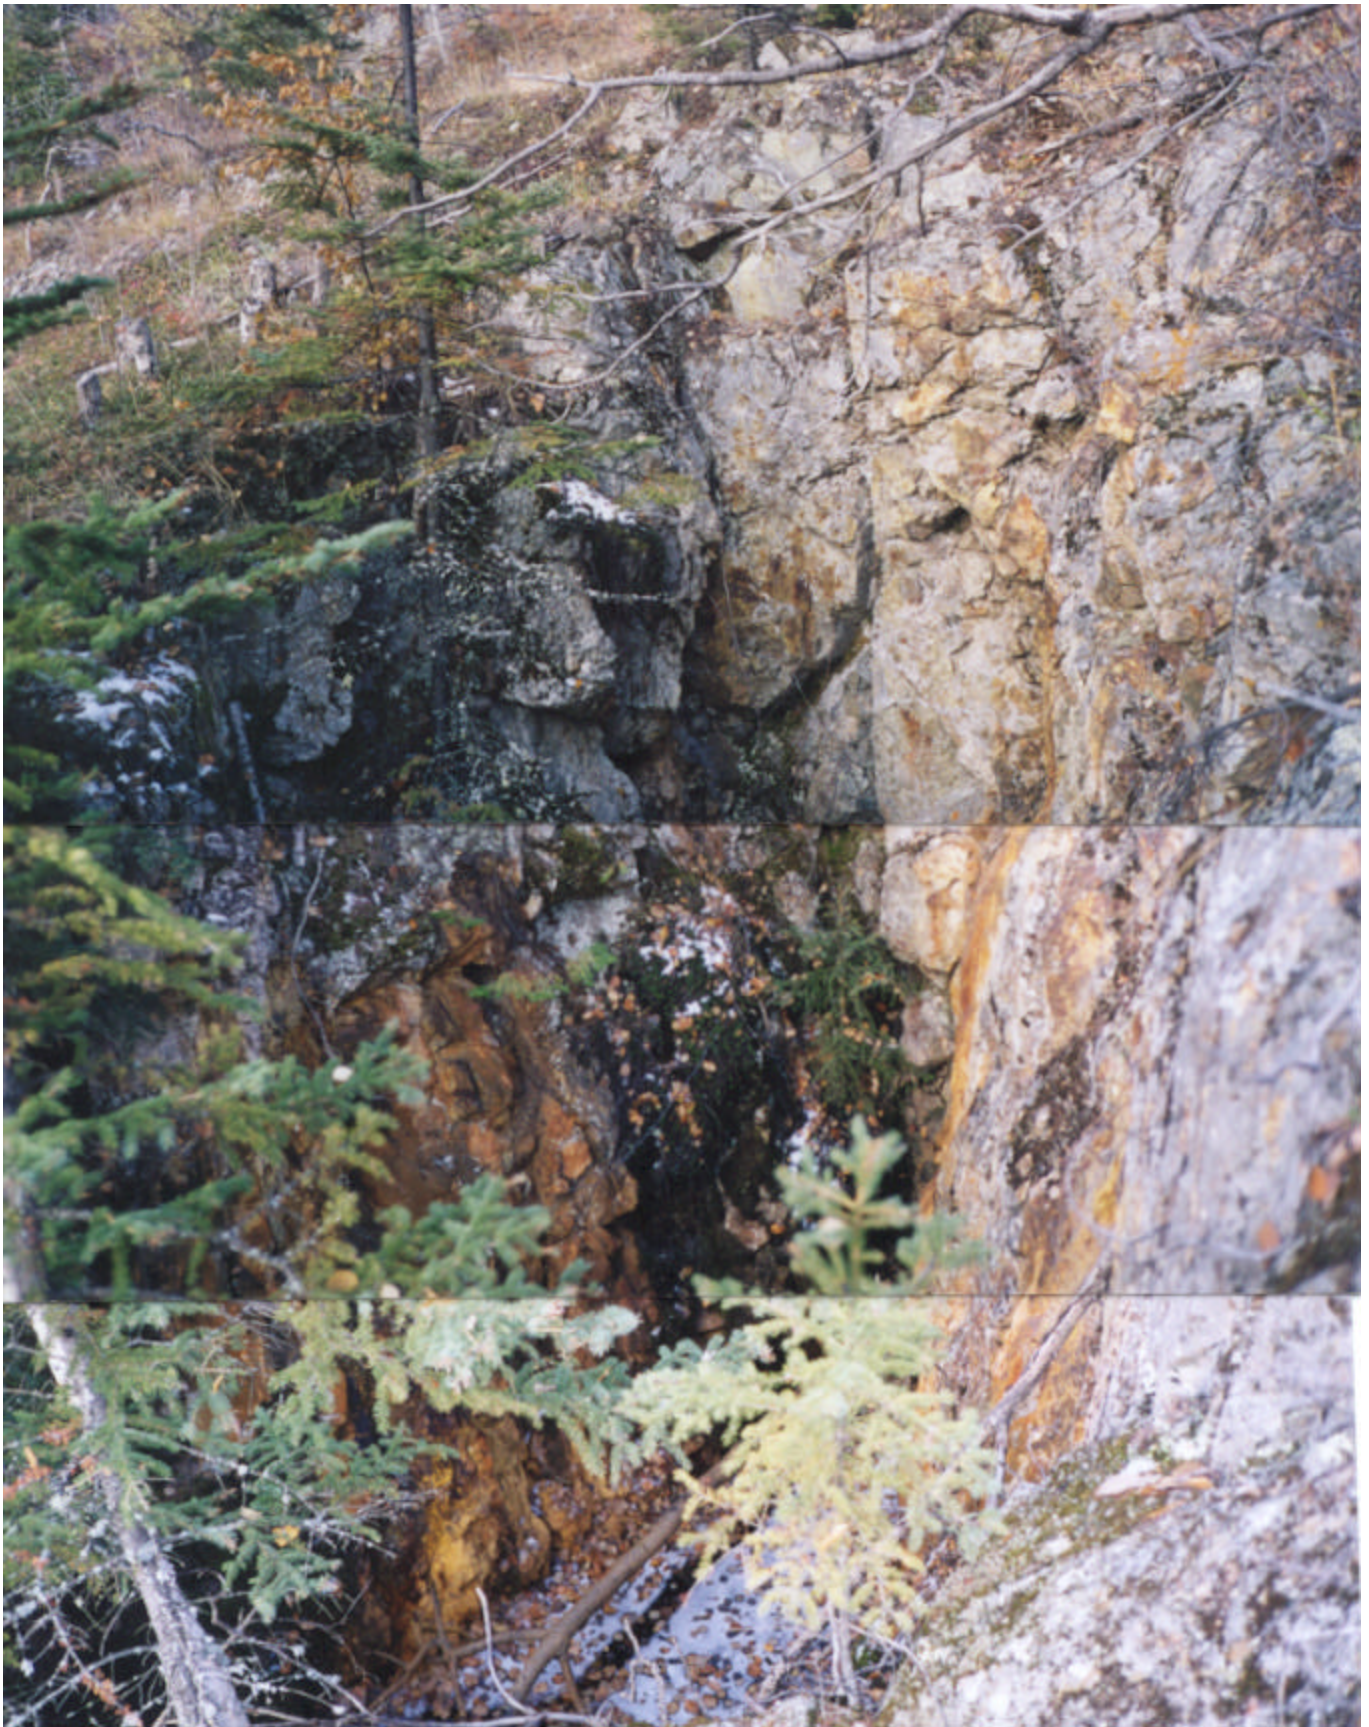
Photograph 6.21-1. Bearcat Showing and Prospect Shaft-Shaft and Waste Rock Area-October 24, 2002

Follow-up activities should focus on sealing the prospect shaft since it poses a public safety risk due to its easy accessibility. The shaft should be secured with a concrete cap or filled-in with local unmineralized rock.

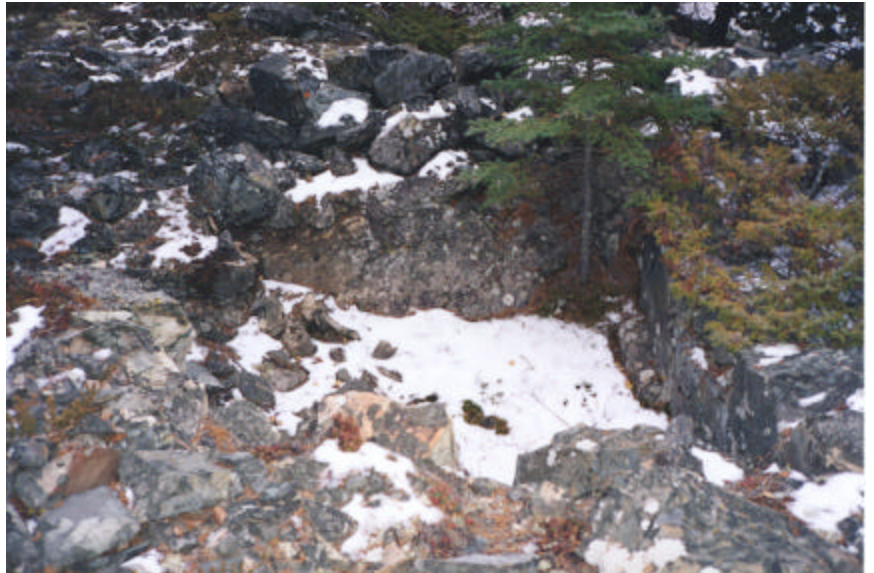
Photograph 6.22-2. Lucky Strike Mine-Trench 'C'-October 24, 2002

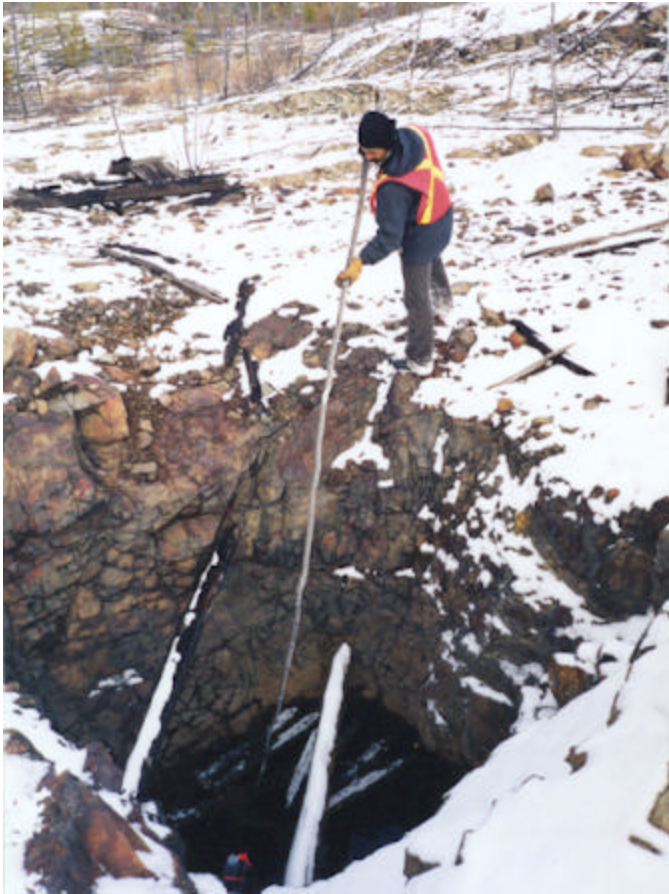
Photograph 6.27-1. Dion Lake Showing and Shaft-Collecting Water Sample at Exploration

Follow-up activities should focus on sealing the exploration shaft since it poses a public safety risk to snowmobilers, hikers etc. The shaft should be secured with a concrete cap or filled-in with local unmineralized waste rock or imported rock. Hazard warning placards should be posted should reclamation activity be delayed.

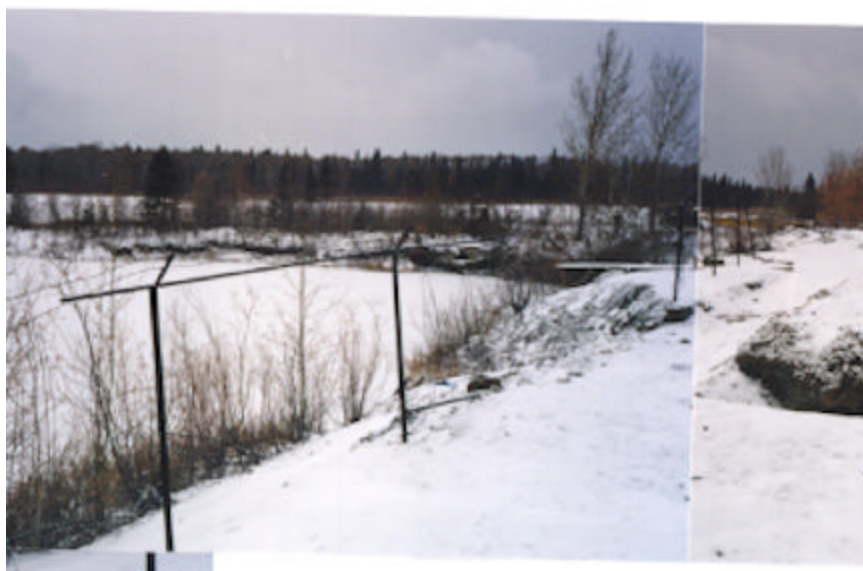
Photograph 6.29-3. Coronation Mine-Concrete Foundation 'A' (Mine Shop?)-October 28, 2002.

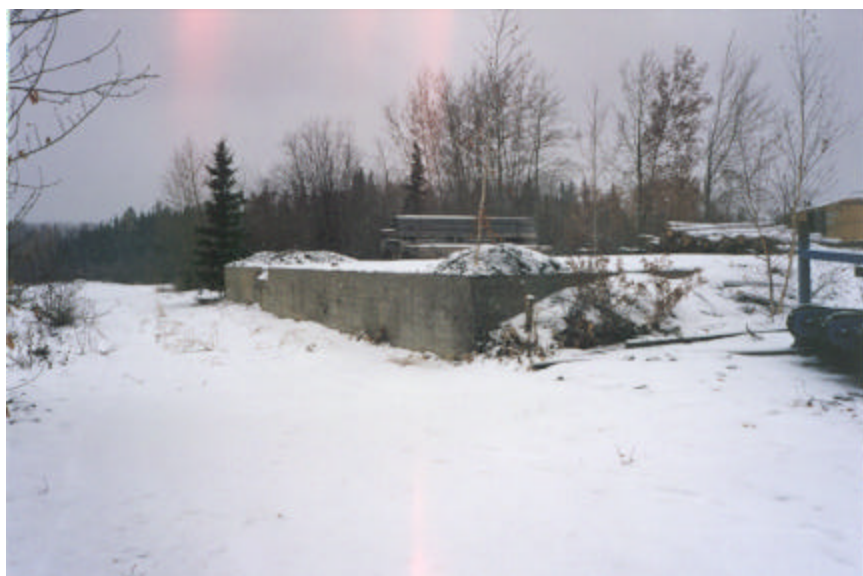
Photograph 6.29-4. Coronation Mine-Concrete Slab and Footings-October 28, 2002.

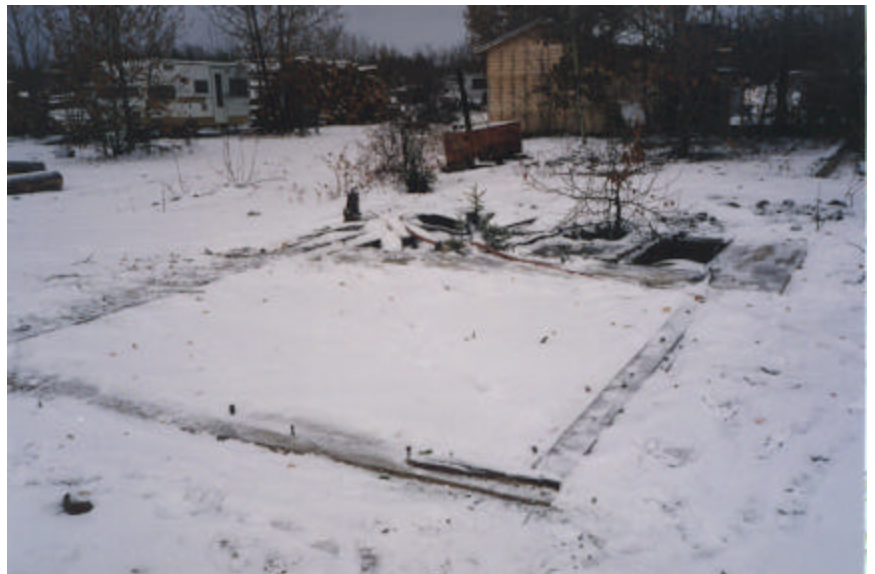
Photograph 6.29-7. Coronation Mine-Concrete Foundation 'E'-October 28, 2002.

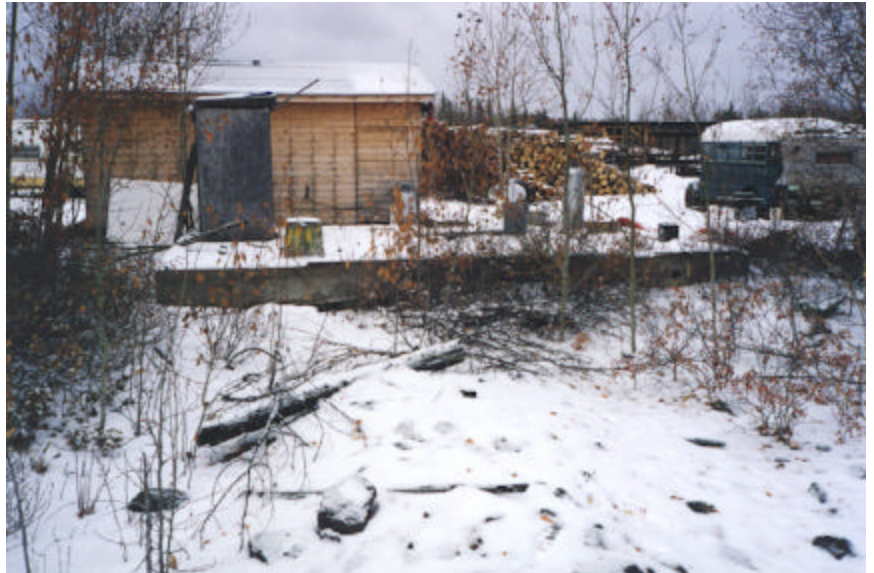
Photograph 6.29-8. Coronation Mine-Loading Platform-October 28, 2002.

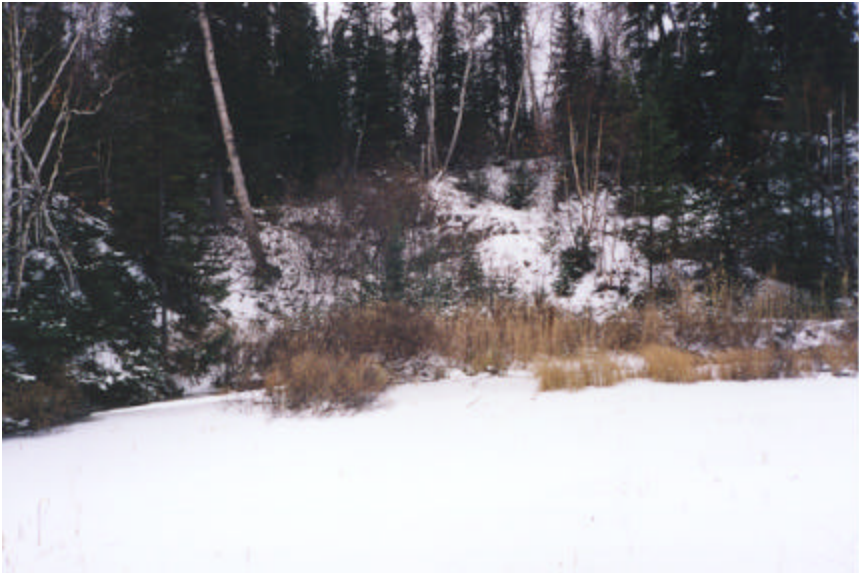
Photograph 6.30-2. Wekatch Gold Mines-Shaft-October 28, 2002
